From: Chad Bunch
To: 19(1) "[REDACTED]@tnpi.ca"
Cc: "[REDACTED]@tnpi.ca"; Dan Barghshoon; Alan Pentney; Kyle Sherwin; Erin Doerffer
Subject: TNPI Montreal Feeder Pipeline, Integrity Inspection Report, August 4-5, 2010
Date: Monday, August 16, 2010 12:02:59 PM
Attachments: [2010 08 05, Montreal Feeder Line Inspection Report.pdf](#)
[2010 08 05, Montreal Feeder Line AVC.pdf](#)

Response to National Energy Board information request in respect to TNPI's leak on the Montreal Feeder System, July 14, 2010.

Detailed Report of Leak from TNPI's 10" Diameter Pipeline Montreal Feeder System Montreal East Province of Quebec. July 14, 2010

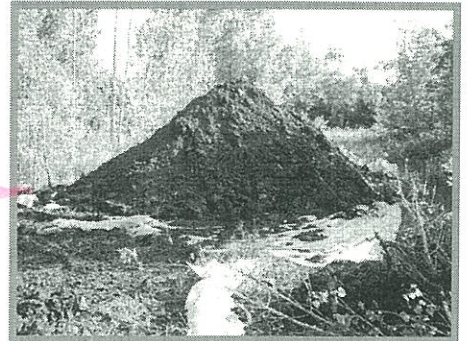
At 14:20 a TNPI inspector found evidence of product over the 10" pipeline adjacent to the Lafarge Roadway on Shell Canada Limited property. Dead vegetation was observed over an area 10 m x 10m. TNPI's Line Control centre was notified and the pipeline was shutdown pending confirmation of a leak on the pipeline.

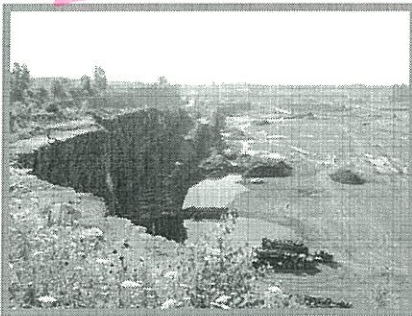
On the morning of July 15th, there had been an accumulation of approximately 200 litres of petroleum product in the excavation. This was recovered by vacuum truck. Product was clearly observed to be weeping from the westerly side of the coating stripped pipe. Excavation continued towards the west where the pipeline trench contained numerous rocks and large boulders. The pipeline coating is wrinkled and a shrink sleeve over a weld was disbonded.

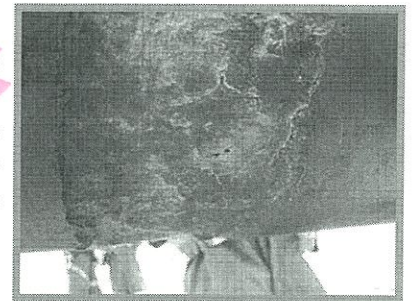
At 12:20 hours on July 15th, the leak was discovered to be two corrosion pits located 8" east of the first weld east of the 90 degree bend adjacent to the Lafarge roadway and fence. There is a 4" wide band of pipe circumference that appears to have been missed during the application of the shrink sleeve that was applied over the weld joint. Corrosion pitting is evident from the 3:00, through 6:00 and to the 9:00 position on the pipe, with the two leaking corrosion pits located at the 6:00 position.

The primary underlying cause of the incident is corrosion due to an improperly aligned and improperly installed Canusa shrink sleeve that was installed in 1995. Secondly, the presence of magnesium anodes in close proximity to the leak site and the apparent levels of cathodic protection present, as identified in previous close interval surveys failed to protect the pipeline from corrosion. An explanation for the cause of the corrosion and the failure to detect active corrosion is needed. The current belief is high resistivity soil and rock impair cathodic protection and that rocks in the backfill shield the pipe from receiving adequate protective values nearest the pipe.

The leaking defect under the PLIDCO split repair sleeve will be cut-out of the pipeline and replaced with a segment of pretested pipe. This work is tentatively scheduled to proceed during the week of August 2nd, subject to the findings of TNPI's ongoing investigation into the condition of the other portions of this 1995 vintage segment of pipeline.

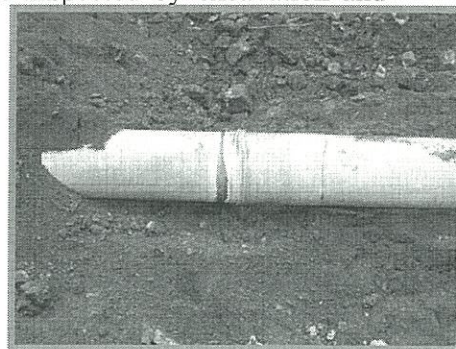
In addition, TNPI excavated the remainder of the pipe in both the easterly direction and the northerly direction to check the condition of the pipeline coating for disbondment. The yellow jacket coating was discovered to be wrinkled and disbonded where the petroleum product has dissolved the primer under the polyethylene jacket. Canusa shrink sleeves applied over the welds was also found to be disbonded and in one case it appears the shrink sleeve was shifted to expose the pipe.

The 1995 segment of pipe will be fully exposed and inspected. Coating which is found to be damaged or disbonded will be replaced with Kema Tape. The pipeline will be backfilled with

padding material to a minimum depth of 12" over the pipeline. Large rocks, present in the existing soil will not be used for backfill. The magnesium anodes removed during excavation will be replaced and connected to the pipeline through testposts.

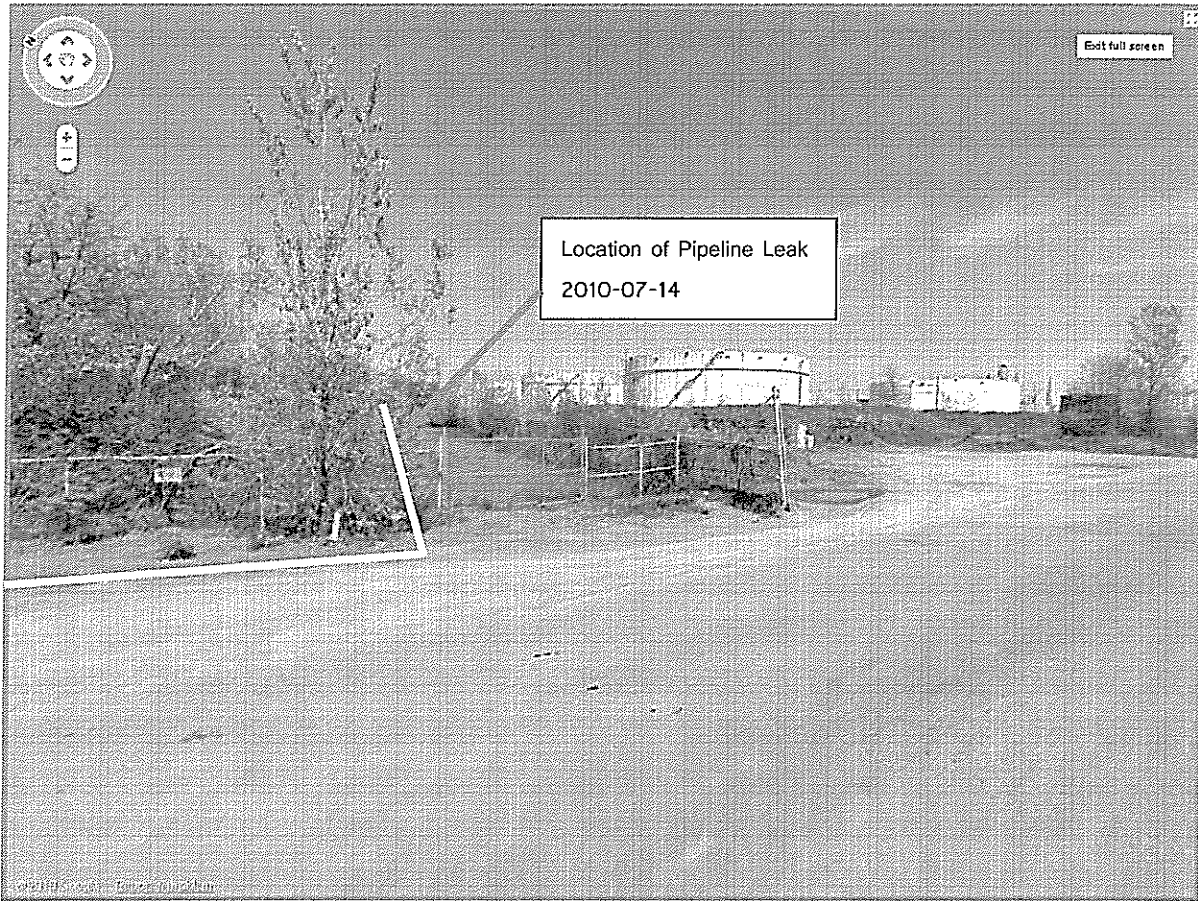
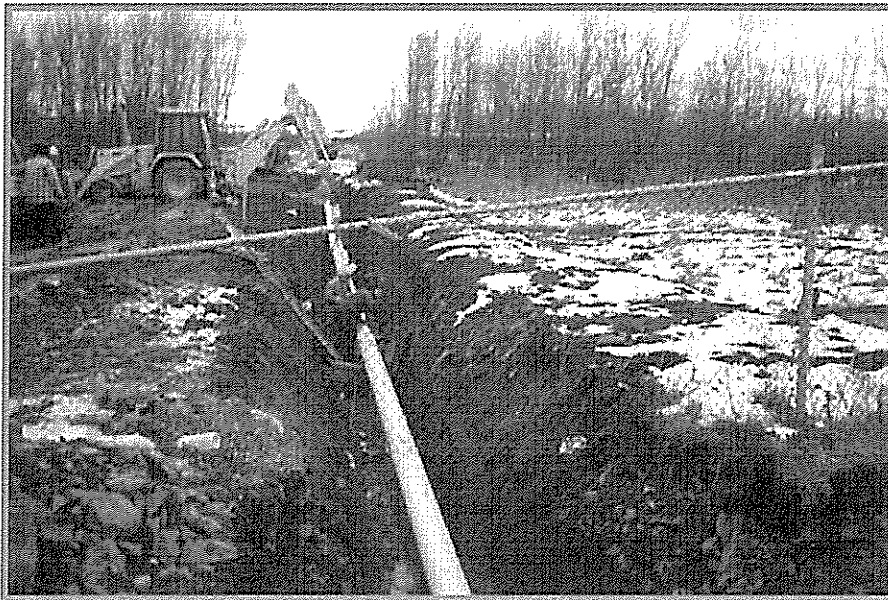
The Photograph at left, taken during construction of the pipeline relocation in 1995, depicts the exact location where the pipeline leak was discovered on July 15th. The location of the leak is 8" east of the first weld east of the 90 degree bend adjacent to the Lafarge roadway and fence.

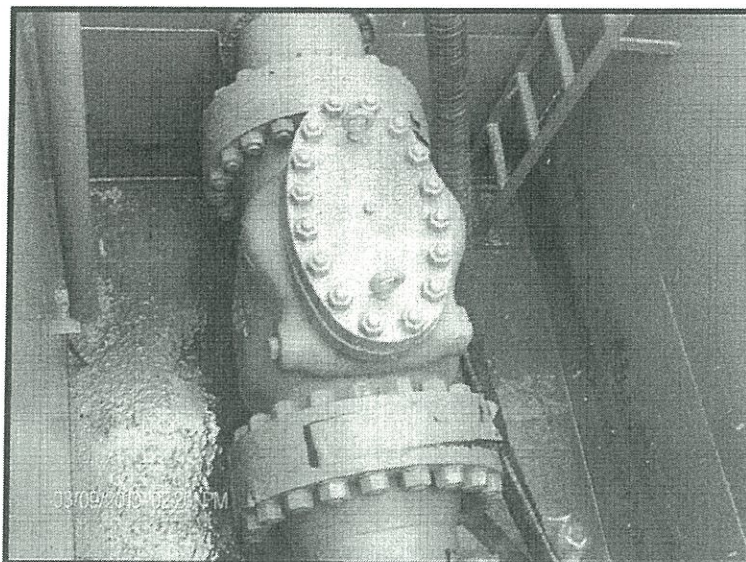
FIGURE # 1
 Check valve in as-found condition
 (picture taken during the excavations and provided by the client)

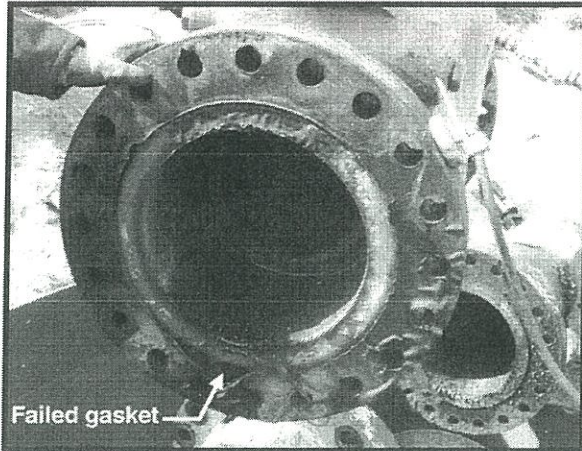
FIGURE # 4
General view of the failed gasket on the east side of the valve (picture taken during excavation and provided by the client)

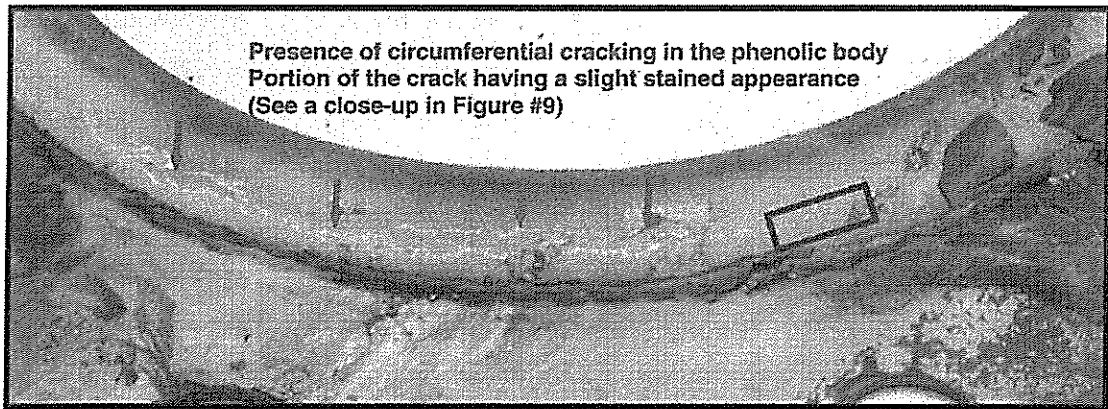
FIGURE # 8

This crack is more pronounced on the face B of the gasket which suggests that it originated on this side. According to the on-site observations, it was thought that a great portion of the crack was produced by manipulations during valve removal. However, since at one location the crack's edges seemed to have been stained and old-looking, it was thought that the crack was initiated prior to removal. This hypothesis was verified at our laboratory by visual observation. The stained appearance in the crack edges at this particular location was no longer visible when observed at high magnification and the morphology of the crack is the same on its length (Figure #9). Our observations suggest that this cracking was entirely produced during valve removal.

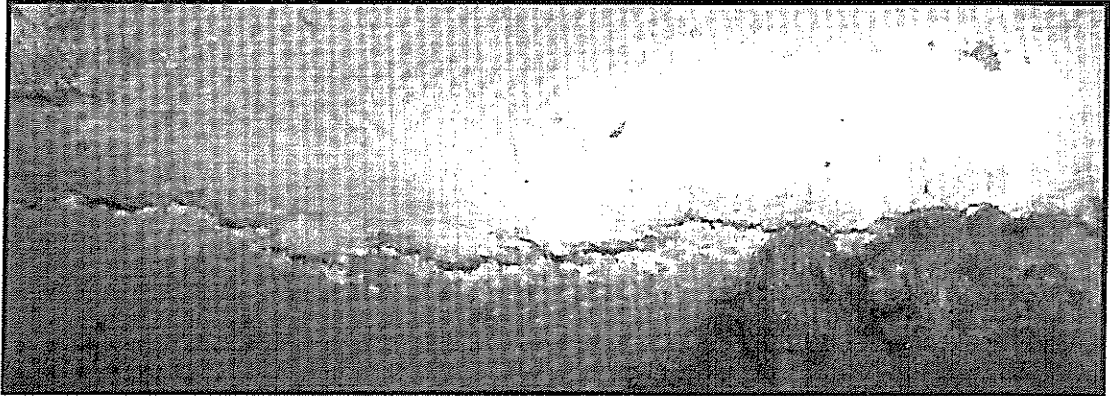
FIGURE # 9
Close-up view of the cracking found in the phenolic body.

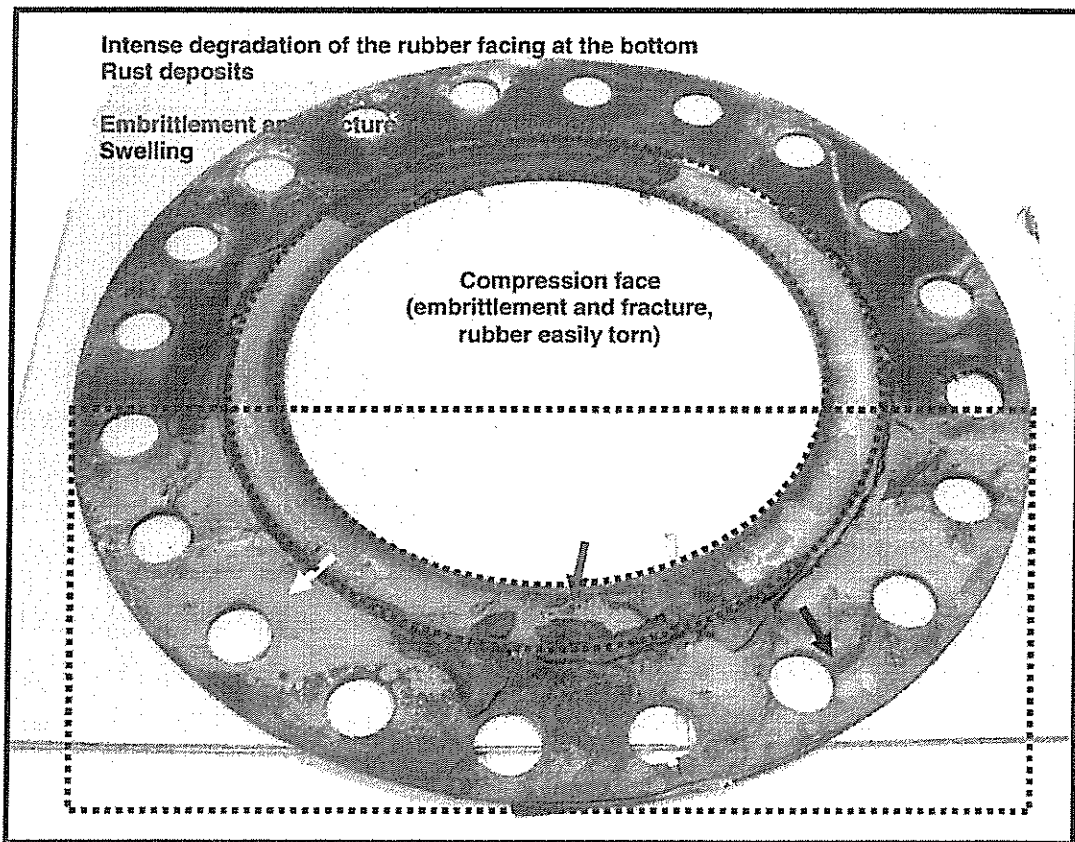
FIGURE # 10
Illustration of the degradation present in the rubber facing (face B, similar in face A).

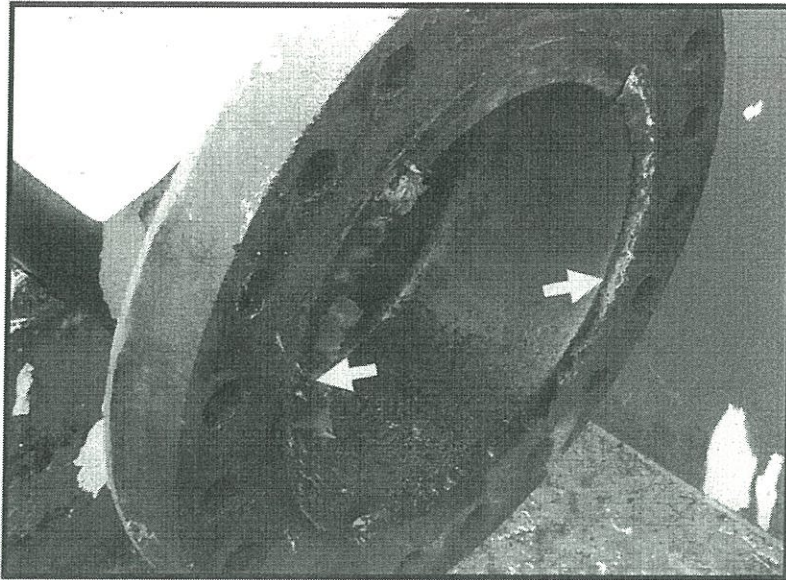
FIGURE # 11
Portions of rubber facing torn apart on the compression face during dismantling.

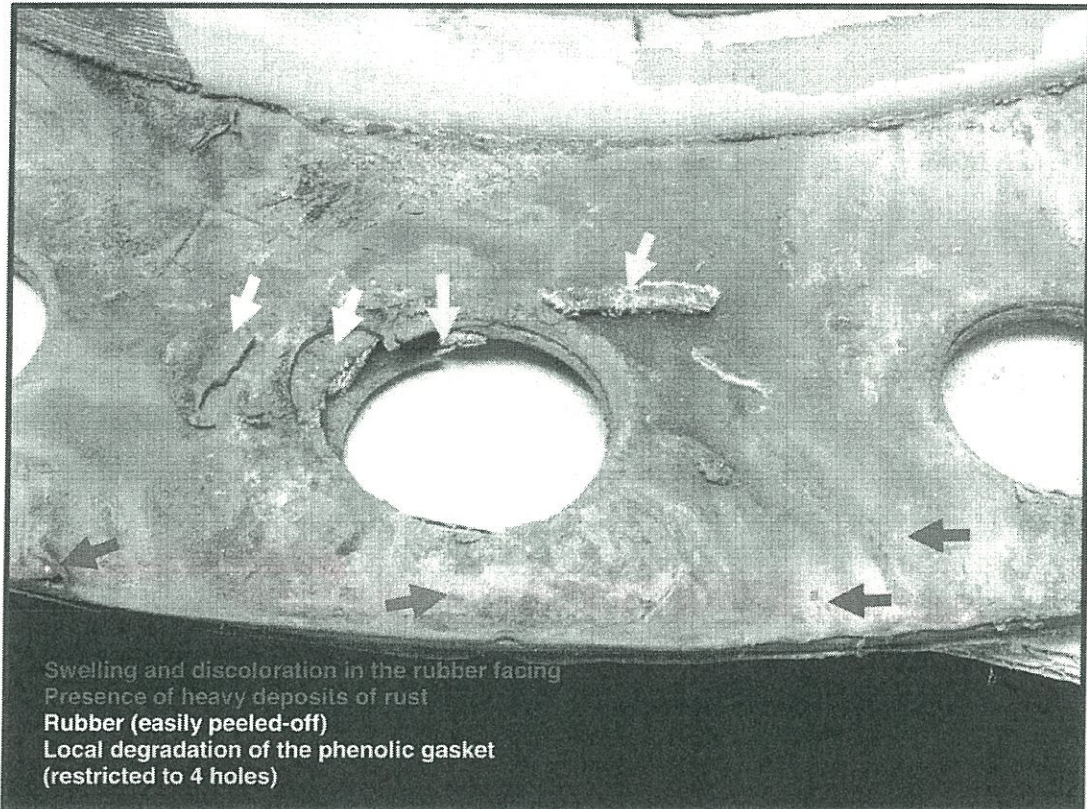
FIGURE # 12
Portions of rubber facing torn apart during dismantling.

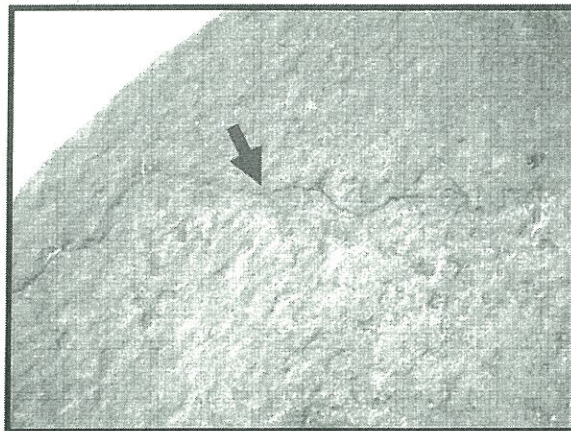
a) Cracking.

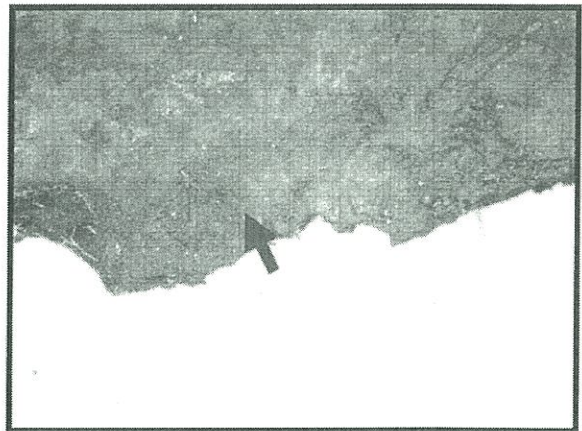
b) Charred surface.

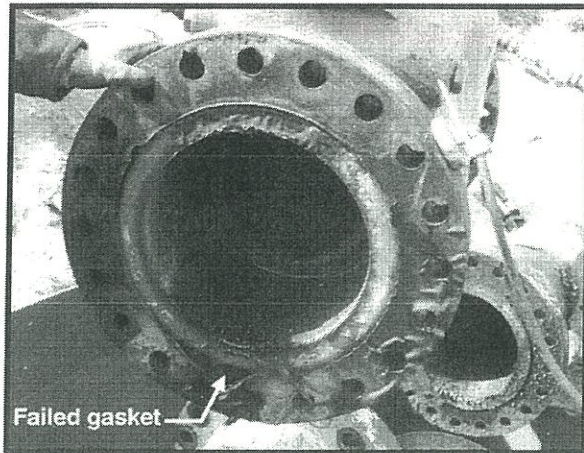
FIGURE # 4
General view of the failed gasket on the east side of the valve (picture taken during excavation and provided by the client)

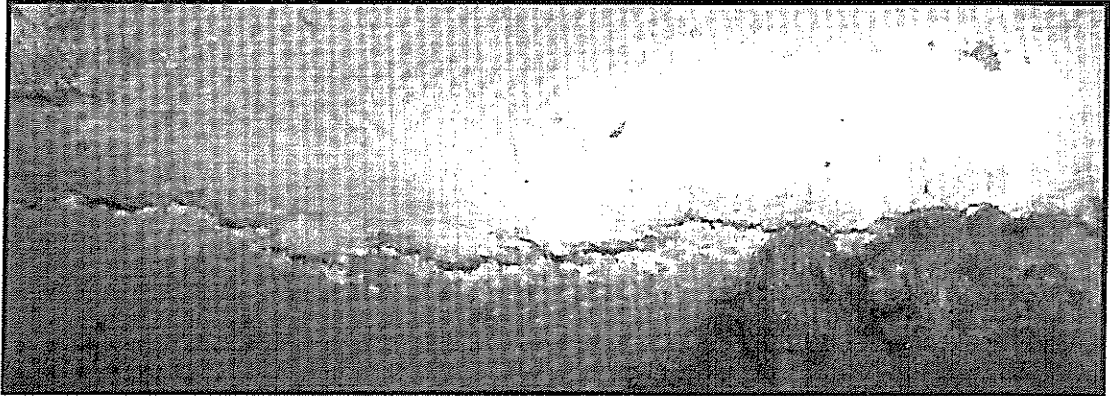
FIGURE # 9
Close-up view of the cracking found in the phenolic body.

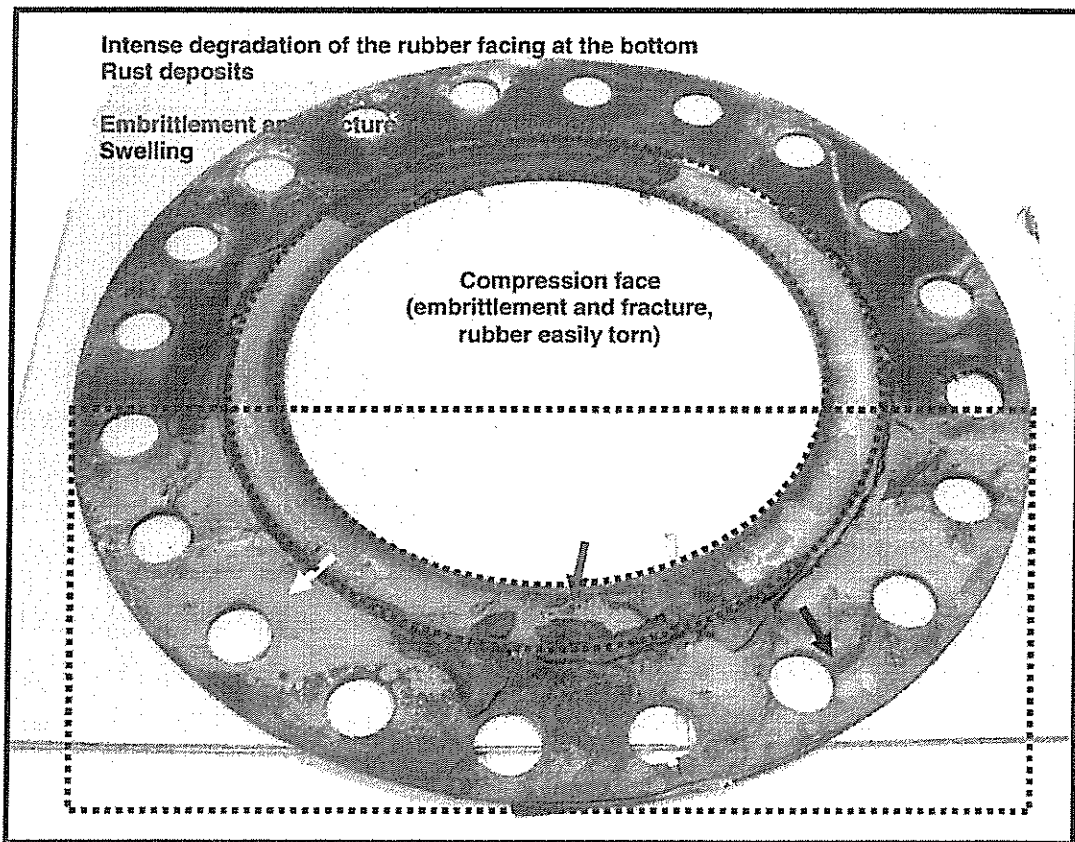
FIGURE # 10
Illustration of the degradation present in the rubber facing (face B, similar in face A).

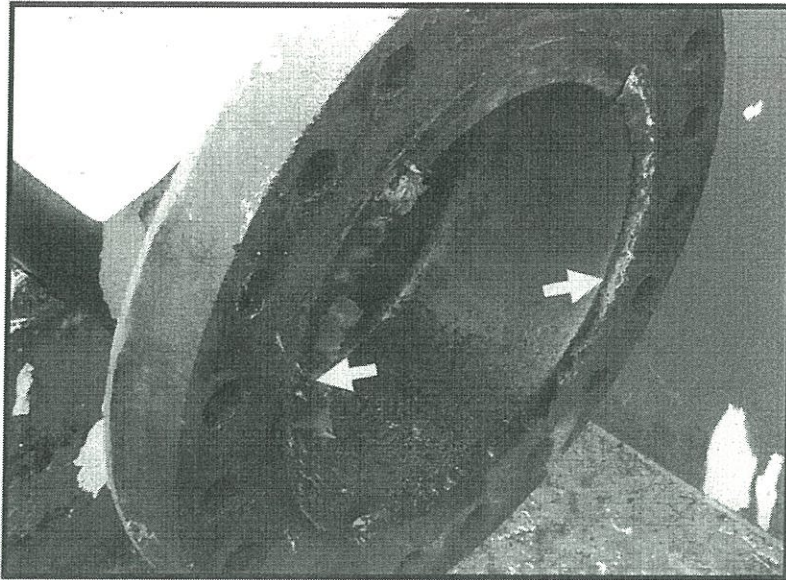
FIGURE # 11
Portions of rubber facing torn apart on the compression face during dismantling.

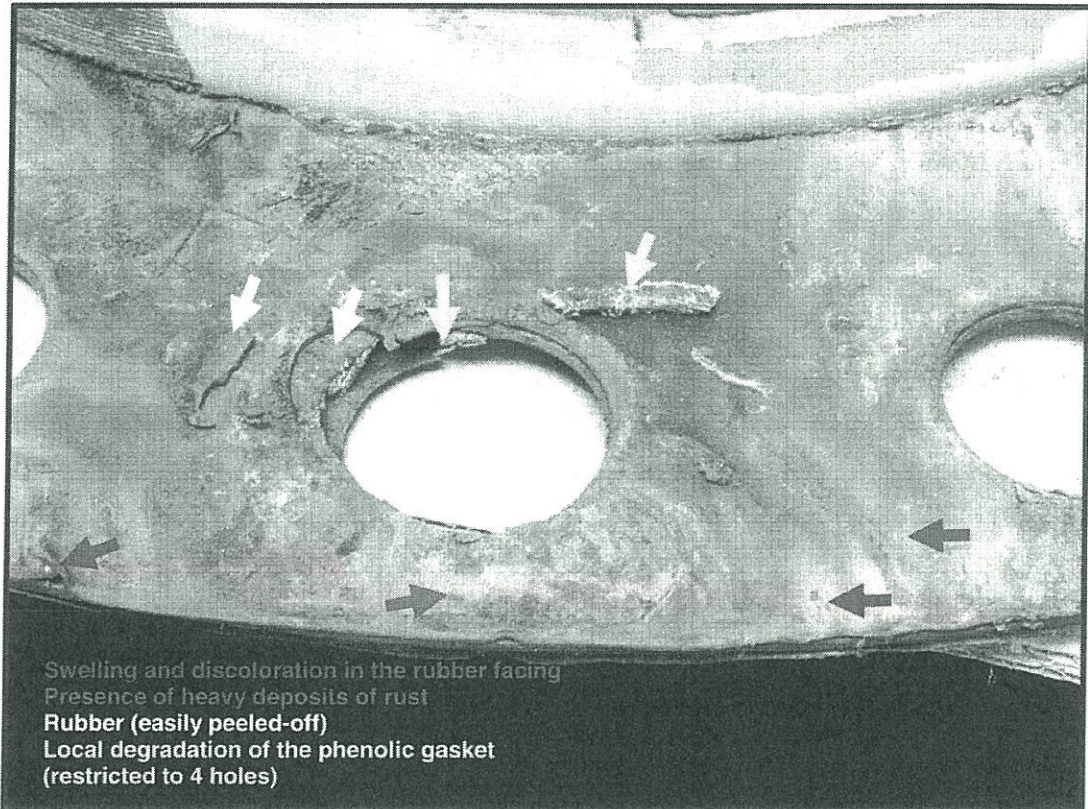
FIGURE # 12
Portions of rubber facing torn apart during dismantling.

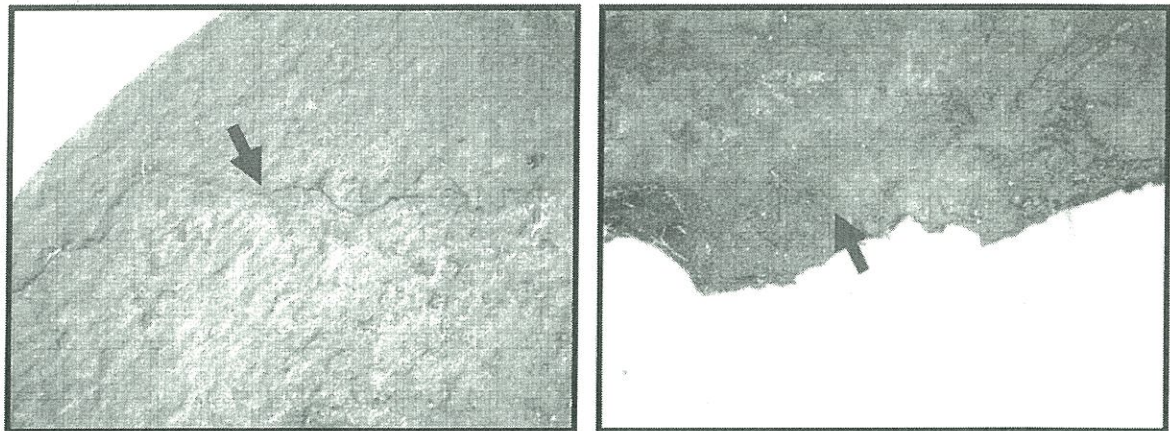
a) Cracking.
