From: Chad Bunch
To: 19(1) "[REDACTED]@tnpi.ca"
Cc: "[REDACTED]@tnpi.ca"; Dan Barghshoon; Alan Pentney; Kyle Sherwin; Erin Doerffer
Subject: TNPI Montreal Feeder Pipeline, Integrity Inspection Report, August 4-5, 2010
Date: Monday, August 16, 2010 12:02:59 PM
Attachments: [2010 08 05, Montreal Feeder Line Inspection Report.pdf](#)
[2010 08 05, Montreal Feeder Line AVC.pdf](#)

Response to National Energy Board information request in respect to TNPI's leak on the Montreal Feeder System, July 14, 2010.

Detailed Report of Leak from TNPI's 10" Diameter Pipeline Montreal Feeder System Montreal East Province of Quebec. July 14, 2010

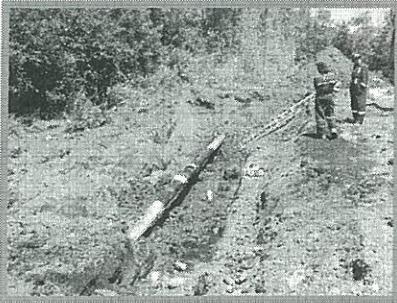
Excavation began around 19:00 hours and continued until 23:00 hours. Approximately 10 metres of pipe was exposed and a portion of the coating had been removed, with no sign of the source of the leak. Contaminated soils were piled on plastic sheeting and covered with tarpaulins. Work ceased for safety reasons, because the backhoe operator and others in the work crew had been working 17 hours and needed rest. An update was provided to the Transportation Safety Board at that time. Two labourers were left on site as watchmen overnight. The site is secured by chain link fencing.

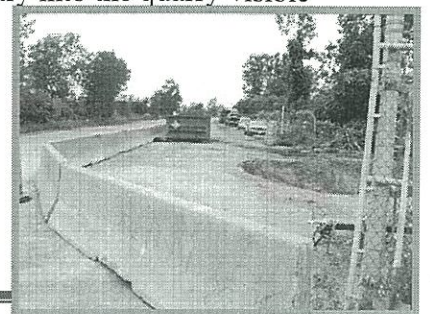
Work resumed and no obvious signs of leakage were identified on the 10

metres of pipe that had been fully exposed and stripped of its coating. Excavation was approximately 3 metres from the 90 degree bend within the Lafarge roadway. Traffic cones and a flag person were necessary to continue excavation along the roadway. Traffic cones were replaced by concrete jersey barriers.

At 12:20 hours on July 15th, the leak was discovered to be two corrosion pits located 8" east of the first weld east of the 90 degree bend adjacent to the Lafarge roadway and fence. There is a 4" wide band of pipe circumference that appears to have been missed during the application of the shrink sleeve that was applied over the weld joint. Corrosion pitting is evident from the 3:00, through 6:00 and to the 9:00 position on the pipe, with the two leaking corrosion pits located at the 6:00 position.

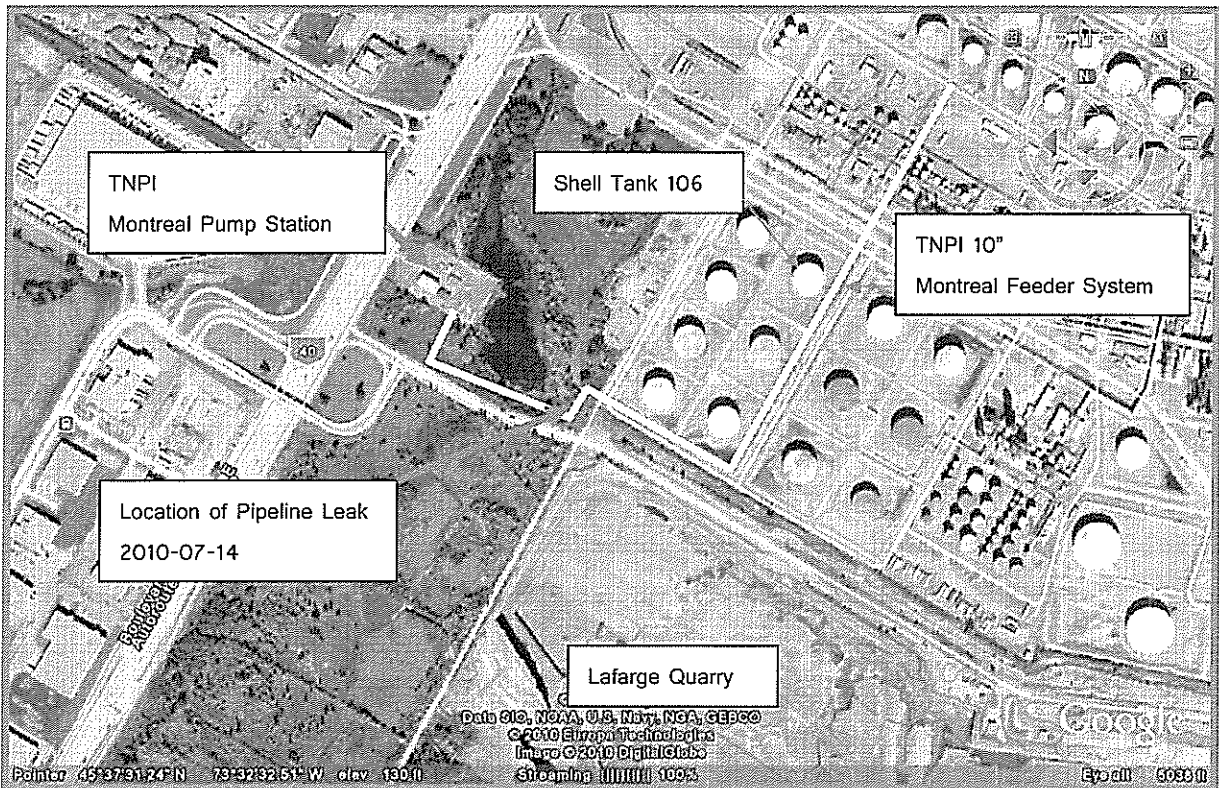
The Photograph at left, taken during construction of the pipeline relocation in 1995, depicts the exact location where the pipeline leak was discovered on July 15th. The location of the leak is 8" east of the first weld east of the 90 degree bend adjacent to the Lafarge roadway and fence.

The primary underlying cause of the incident is corrosion due to an improperly aligned and improperly installed Canusa shrink sleeve that was installed in 1995. Secondly, the presence of magnesium anodes in close proximity to the leak site and the apparent levels of cathodic protection present, as identified in previous close interval surveys failed to protect the pipeline from corrosion. An explanation for the cause of the corrosion and the failure to detect active corrosion is needed. The current belief is high resistivity soil and rock impair cathodic protection and that rocks in the backfill shield the pipe from receiving adequate protective values nearest the pipe.

The 1995 segment of pipe will be fully exposed and inspected. Coating which is found to be damaged or disbonded will be replaced with Kema Tape. The pipeline will be backfilled with

padding material to a minimum depth of 12" over the pipeline. Large rocks, present in the existing soil will not be used for backfill. The magnesium anodes removed during excavation will be replaced and connected to the pipeline through testposts.

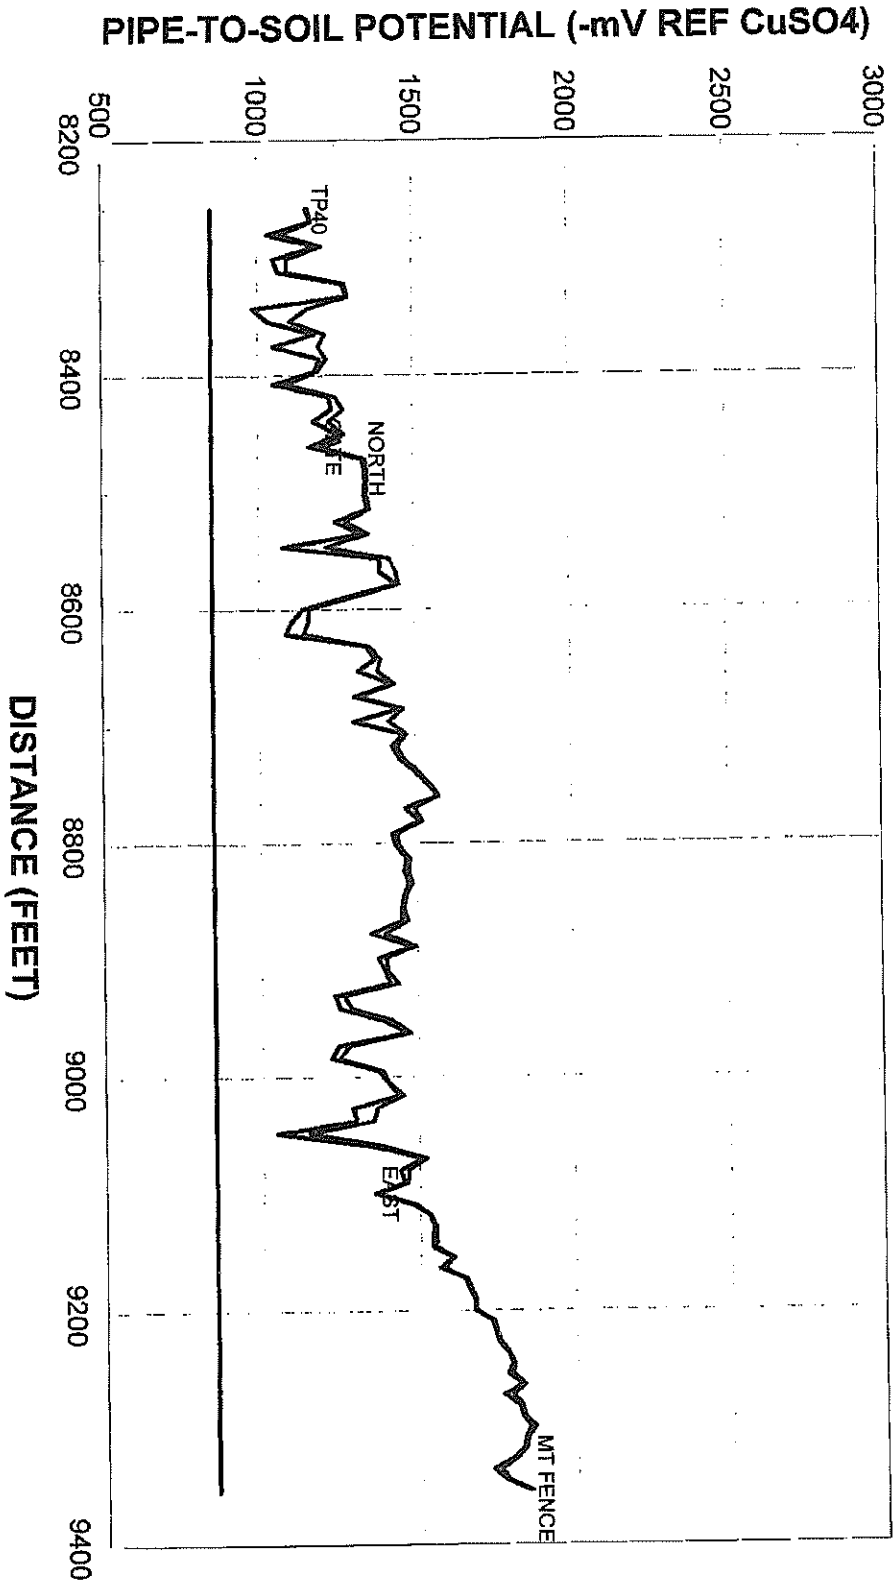
TRANS-NORTHERN PIPELINES INC. FEEDER SYSTEM SHELL FENCE TO MT FENCE

The feeder system meets the cathodic protection criteria with the exception of the areas in the vicinity of test post 33 and test post 35. These two areas fall within the spill containment for tanks 107 and 108. The charted data shows the potentials rise and fall as the survey crosses over the magnesium anode locations. Additional anodes will be required in this area. The chart on the following page shows the area discussed.

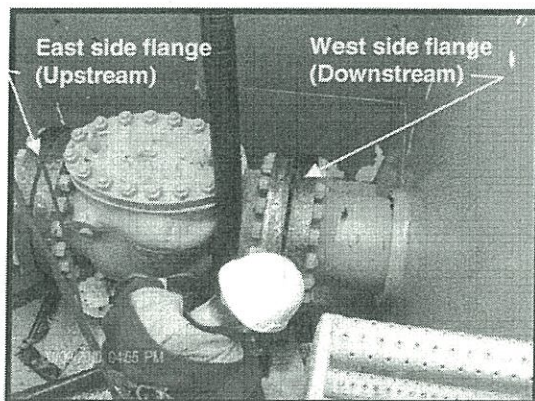
A leak occurred from this connection during February 2010. According to the client, when the gasket was removed, the flanges were found to be “in good condition”, having the studs and nuts tight. However, the gasket itself seemed to have been damaged and was considered responsible for the spilling. Figures #2 to #6 show general images of the flanges and the gasket, during excavation operation.

FIGURE # 2
 General view of the check valve (picture taken during excavation and provided by the client)

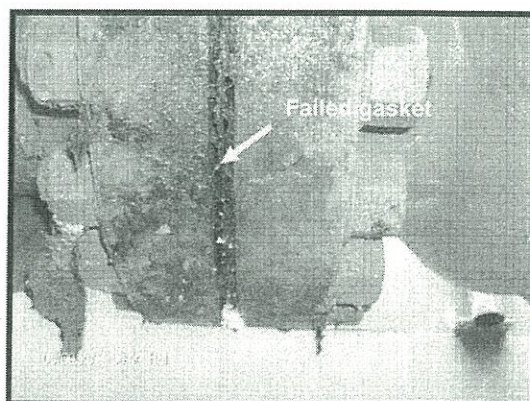
FIGURE # 3
 Close-up view of the flange assembly on the east side of the valve (picture taken during excavation and provided by the client)

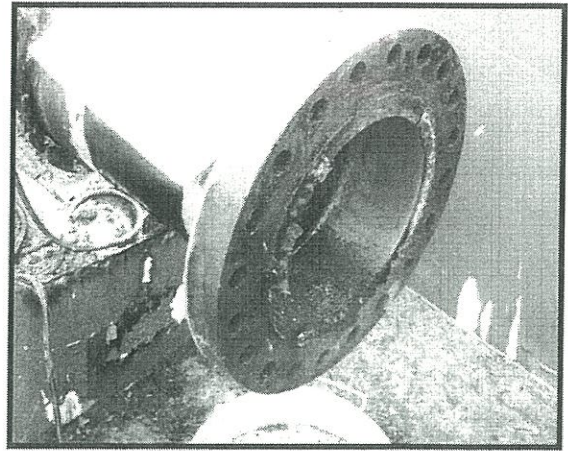
FIGURE # 5
General view of the flange on the east side of the valve (picture taken during excavation and provided by the client)

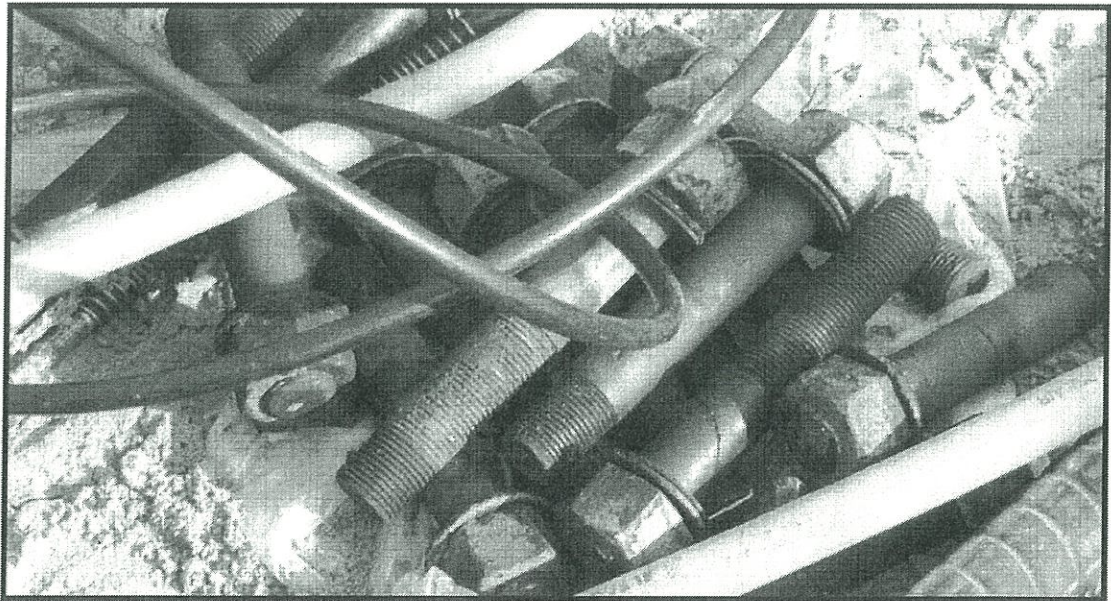
FIGURE # 6
General view of some of the bolts used to secure the flanges (picture taken during the excavations and provided by the client)

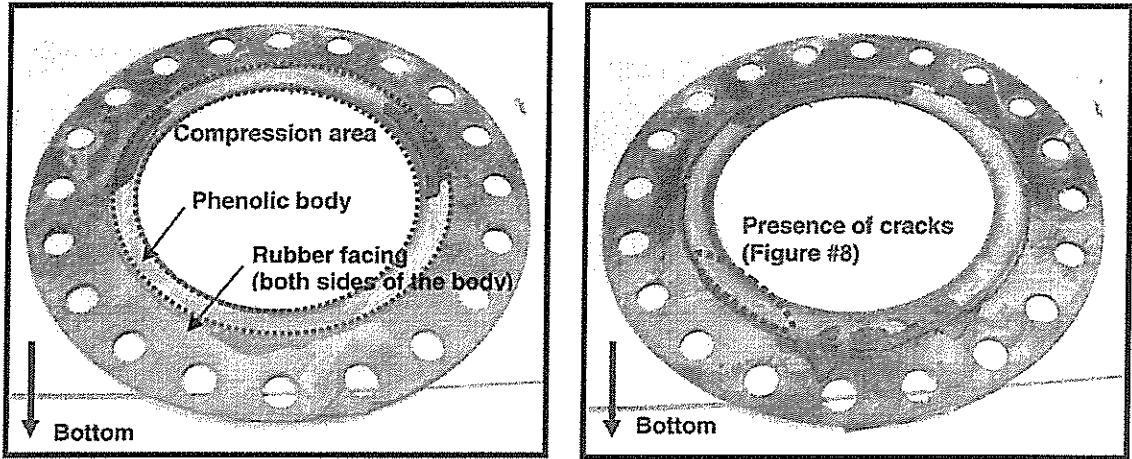
FIGURES # 7

General images of the failed gasket, in as-submitted condition, are presented in Figures #7. The two faces of the gasket were labelled A and B at our laboratory and their position in Figures #7 is consistent with their position in the flange connection. Visual examination of the failed gasket first showed that the heavy damage exhibited by the gasket seem to be found rather in the rubber facing than in the phenolic body (Figures #7). Indeed, a closer look at the gasket found that the only apparent damage in the phenolic body is a circumferential cracking noted on one side and oriented towards the bottom of the connection, in the compression area (Figures #7).

a) Face A (West side of the gasket).

b) Face B (East side of the gasket).

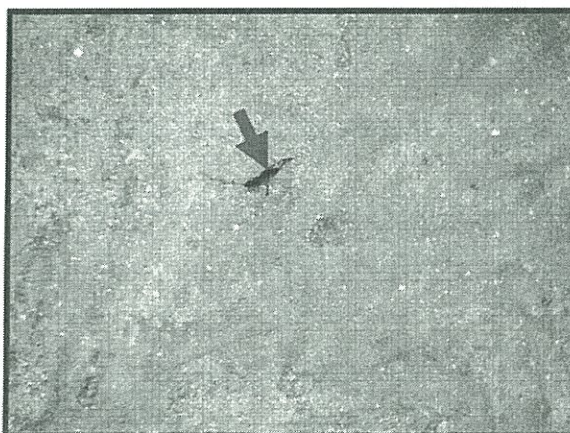
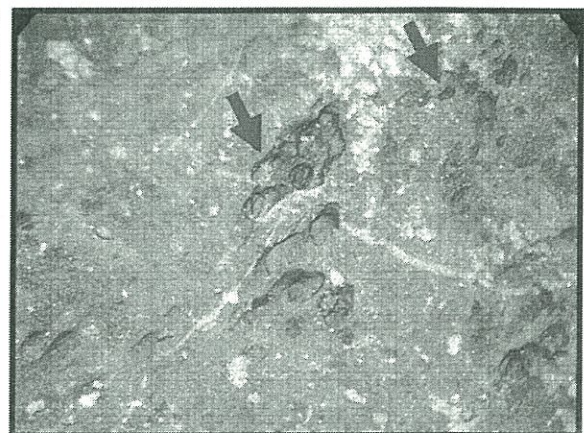
FIGURES # 13

the phenolic body, in the form of embrittlement and fracture, was identified at the edges of some 4 holes (Figure #13).

Low-magnification examination was conducted on sections of rubber facing detached from the bottom side of the gasket, and from the compression area between the raised faces of the flanges, to assess the degradation at microscale. At about 63 X magnification, it was found that the rubber surface presents charring, cracking, perforations and indentations. All these features, equally present the compression area, are illustrated in Figures #13 and #14.

Close-up views of the rubber surface in the bottom area of the gasket, in the compression area between the raised faces of the flanges (63X).

a) Perforation.

a) Indentations.

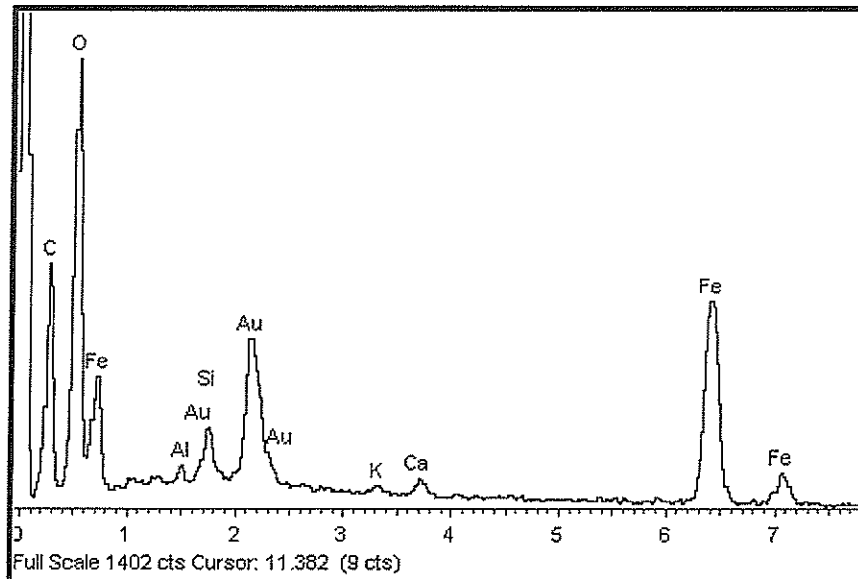
FIGURE # 15
EDX spectrum of the analyzed deposit.

As it can be observed on the EDX spectra, several chemical elements were found in the deposits present at the rubber facing surface. A significant amount of iron oxide was found, as well as carbon, calcium, potassium, zinc, and chlorine. Carbon and oxygen could come from the rubber degradation and from the gasoline transported by the piping system. Silicon could come from the sand and the earth nearby. Iron oxide, most likely in the form of rust, is a by-product of the corrosion process in the metallic parts. Zn could come from galvanizing in the metallic parts and could at the origin of the white particles previously noted at the rubber surface. Calcium, potassium and chlorine could be in form of salts and could be at the origin of the corrosion process in the metallic parts. Combined with water from condensation or from atmospheric humidity, these elements could form acids, such as HCl that can, at length, promote rubber degradation.

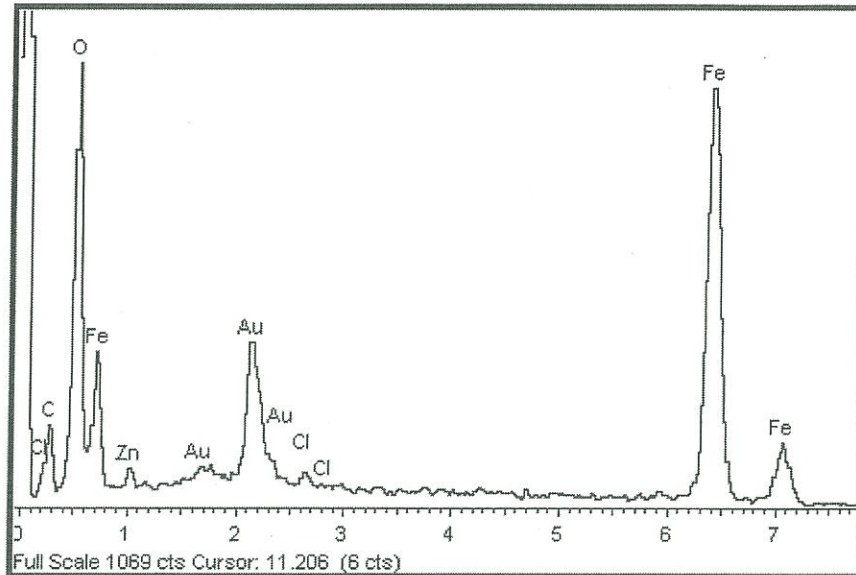
FIGURE # 16
EDX spectrum of the analyzed deposit.

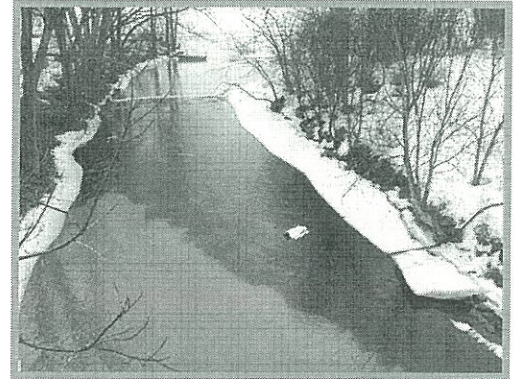
TNPI's emergency response team contacted the initial caller to confirm the location. Within an hour of the initial call to TNPI, TNPI personnel were on site and confirmed that fuel was escaping from a vault containing a 16" check valve. Additional TNPI emergency responders and contractors were dispatched to the scene.

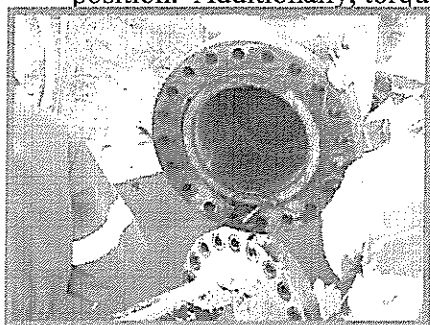
On March 3rd, prior to removing the valve, photographs were taken of both flanges at the 12:00, 03:00 and 09:00 positions. Photos at the 06:00 position were not possible due to the proximity of the vault base. The top of the gasket was marked with a “V” notch to indicate its original position. Additionally, torque testing of the bolts was conducted before attempting to undo any of the bolts from the flanges. All nuts were determined tighter than the specified 1200 fps. This was determined by hydraulic torque gauge.

All of the nuts and studs that were removed were in good shape with no evidence of corrosion or deterioration. The valve was easily removed without the need to spread the flanges indicating good alignment of the pipe segments. On removal the gasket was photographed and preserved in a plastic bag for future

The pipe and valve flange faces were examined and deemed to be acceptable for re-insertion into the pipeline. This was performed without difficulty. The flange faces and bolt holes lined-up without the need for adjustment. New gaskets, studs and nuts were installed in both pipeline flanges. The insulating gasket was replaced with a standard flexitallic gasket since there was no need for isolation with the current cathodic protection system. After the valve was installed and the studs were torqued to specification the pipeline was re-filled with product from Montreal Pump Station.

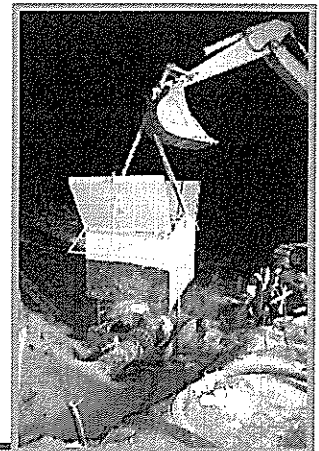
A contractor was brought in to cut through the steel vault with an electric saw to create a safe work environment. The leaking flange was wrapped

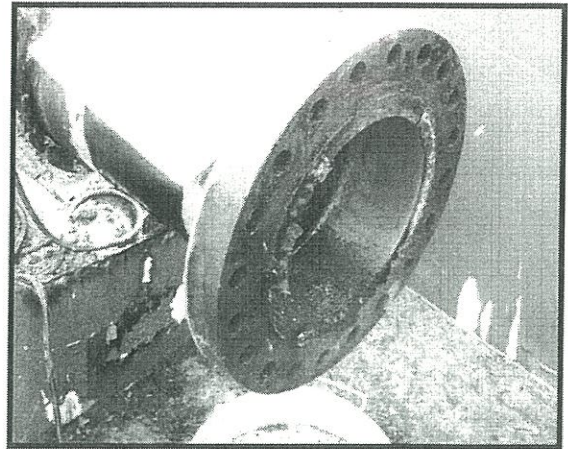
FIGURE # 5
General view of the flange on the east side of the valve (picture taken during excavation and provided by the client)

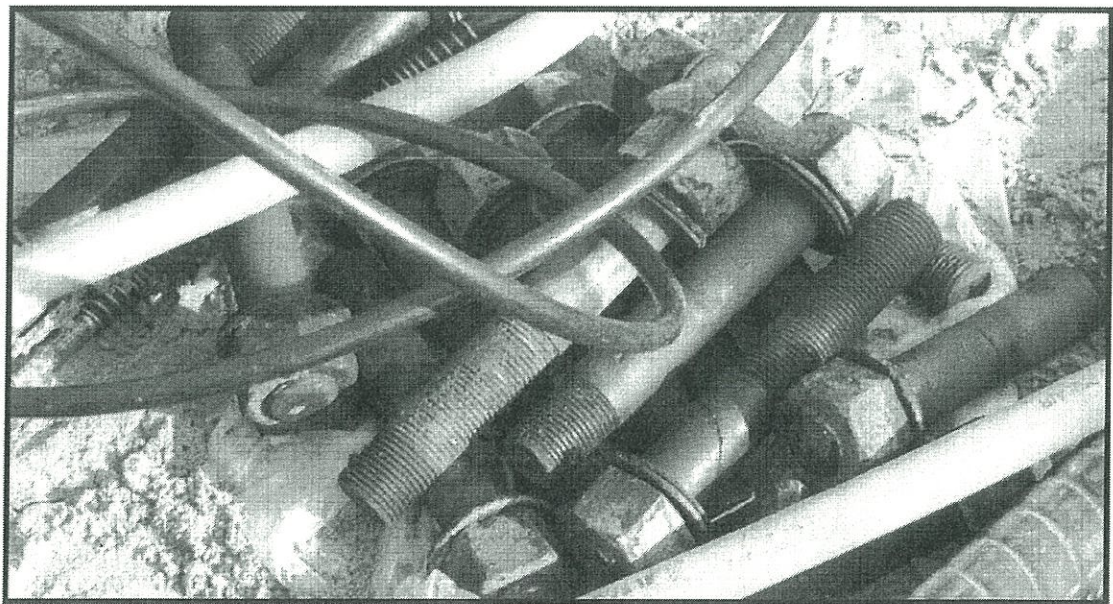
FIGURE # 6
General view of some of the bolts used to secure the flanges (picture taken during the excavations and provided by the client)

As the client informed us, the valve was originally buried in the earth. During 1992, it was excavated and a steel vault was installed to encapsulate the valve. The piping system in this area was cathodically protected at the moment of the original installation, in 1972. However, the fact that the valve was unburied made it susceptible to atmospheric corrosion inside the vault. In the case under investigation, corrosion in progression could indeed be noticed on

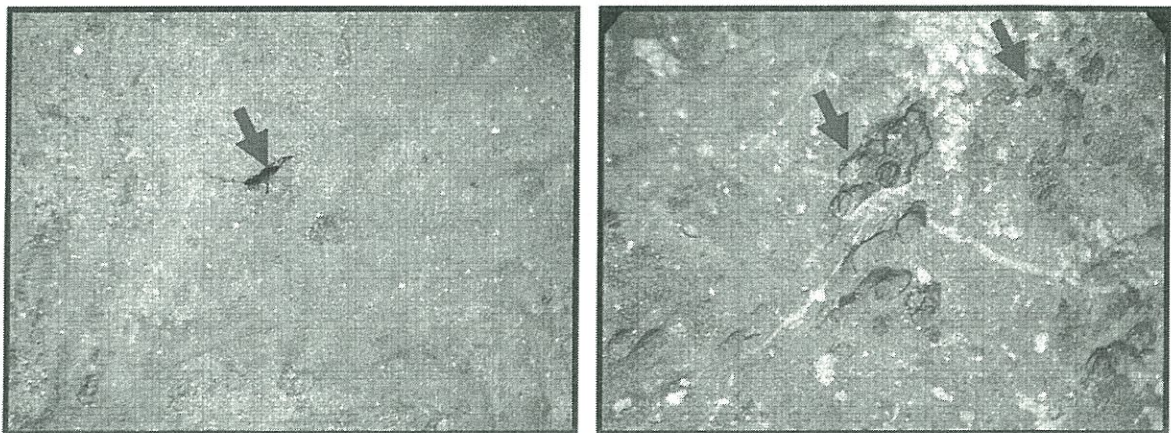
FIGURES # 13

Low-magnification examination was conducted on sections of rubber facing detached from the bottom side of the gasket, and from the compression area between the raised faces of the flanges, to assess the degradation at microscale. At about 63 X magnification, it was found that the rubber surface presents charring, cracking, perforations and indentations. All these features, equally present the compression area, are illustrated in Figures #13 and #14.

Close-up views of the rubber surface in the bottom area of the gasket, in the compression area between the raised faces of the flanges (63X).

a) Perforation.

a) Indentations.

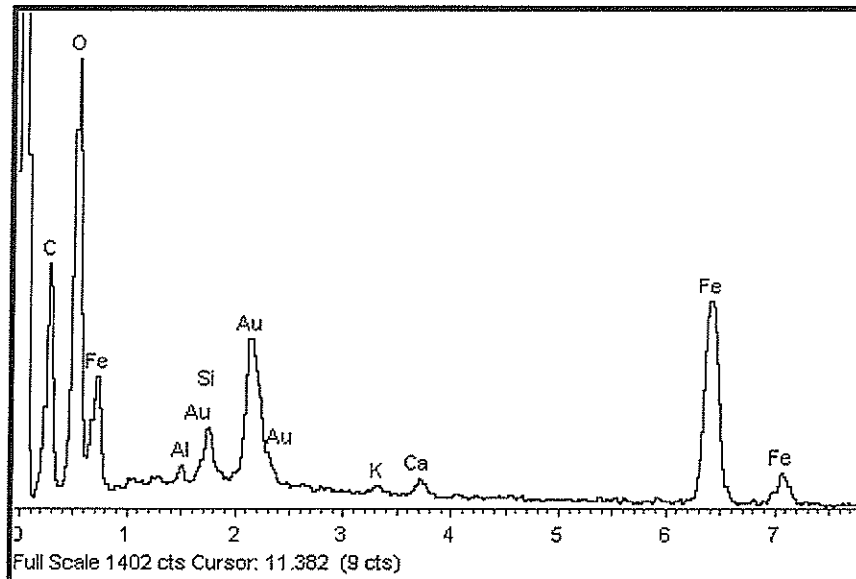
Usually, an EDX (Electron Dispersion X-Ray Spectrometry) analysis that uses SEM techniques is performed in order to evaluate the presence of chemical elements in the degraded areas and in deposits coming from the bottom area of the gasket and from its compression face. This type of analysis provides a rather qualitative assessment of different compounds on a specified and very localized area. In the present case, the EDX analysis was conducted on deposits sampled in degraded areas of the rubber facing, in the bottom region. In this particular case, the EDX analysis aimed to determine whether chemical elements that could be considered aggressive for the rubber were present. Typical spectra of the analyzed deposits are presented in Figures #15 and #16. Presence of element gold (Au) must be disregarded as it was used to prepare the samples for analysis.

FIGURE # 15
EDX spectrum of the analyzed deposit.

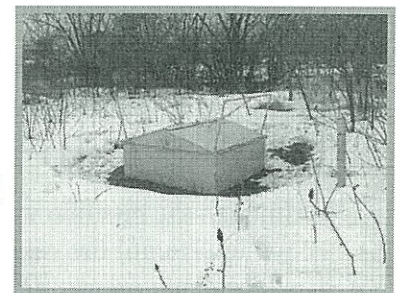
TNPI was advised that emergency services had been working at this site since Friday afternoon (February 26th) in response to a brown coloured liquid in the creek. Environment Quebec and Environment Canada officials originally believed the source of the liquid was from an upstream industrial plant. On February 26th, Ville de Laval officials had installed a boom across Lapiniere Creek and were recovering the accumulated brown coloured liquid to keep it from entering the Riviere des Prairies.

At 11:40 am on February 27th, Environment Canada officials investigating the response discovered the previous day discovered product escaping the vault containing TNPI's valve. An Environment Canada employee measured the leak rate at 1 litre per minute, at which time TNPI's pipeline was operating at 392 psi. This information was later used to determine the maximum

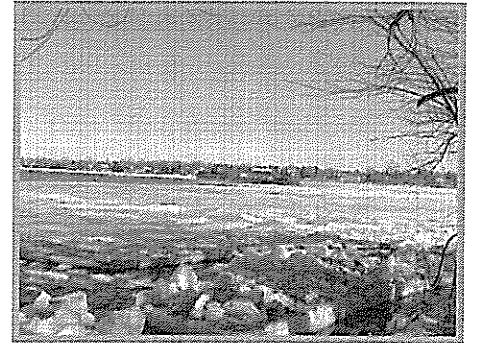
As the water flows in the Riviere des Prairies fluctuated and as the ice thickness deteriorated a floating backhoe was brought to the site on March 6th to break the river ice in order to establish a tighter perimeter but careful not to break the ice clinging to the shoreline. The perimeter booms installed along the Riviere des Prairies were removed and re-deployed closer to shore. During this process it was discovered that the oil had migrated upstream along the bank of Riviere des Prairies to a distance of 450 feet from the pipeline. This new division was bordered by additional floating boom. The total boom deployed in all divisions by the end of the day was 1650 feet. Shore line cleanup in this division continued by water deluge to melt the snow and ice and to displace the trapped oil onto the water surface where it was then collected by adsorbent pads, booms and by vacuum truck.

On March 11th, a Canadian Coast Guard hovercraft made several passes upstream and downstream on the Riviere des Prairies to break-up the ice sheet in the river as a flood control measure. During these passes, waves moved blocks of ice into the booms deployed along the shoreline. Some of the boom was destroyed by ice action. Other portions were displaced. The waves lapped the shoreline well above the static water level and initiated the release of more product and more sheen. It took work crews two days to re-establish the boom divisions that were disturbed by this action. In addition a change of wind direction forced the broken ice flows into the booms parallel to the river shoreline. When the wind direction changed two days later the broken ice flows eventually drifted downstream and the booms were re-secured.
